SERVICE DATA SHEET

Heat Exchanger Reconditioning – Tube Sheet

Heat Exchanger Reconditioning – Tube Liner

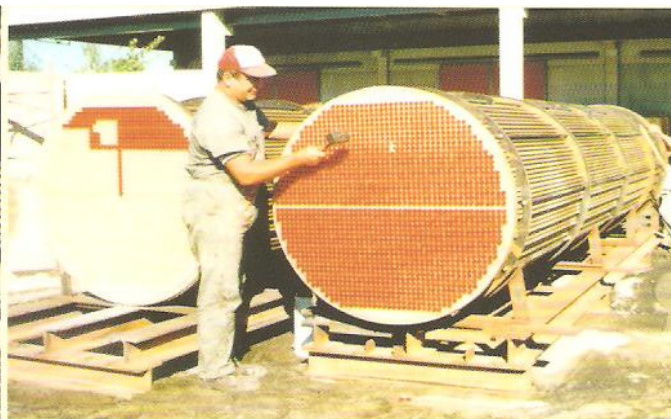
Tube sheet Bunging

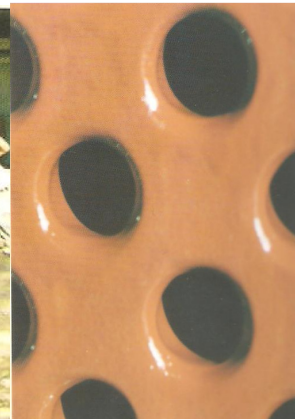
Tube sheet protection

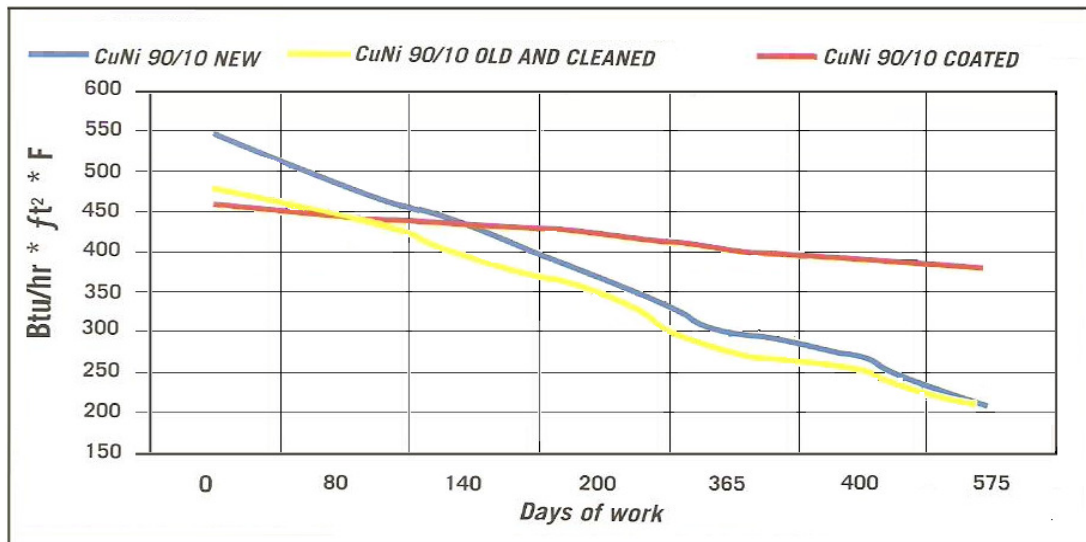
The graph shows the performances over time of coated tubes

Coated tubes grant excellent thermal property losing only 5% of the performances versus new tubes, granting a system protection, long life and constant performances opposite than uncoated tubes that tend to decline the thermal exchange properties in short time periods.
